Culvert Inspection

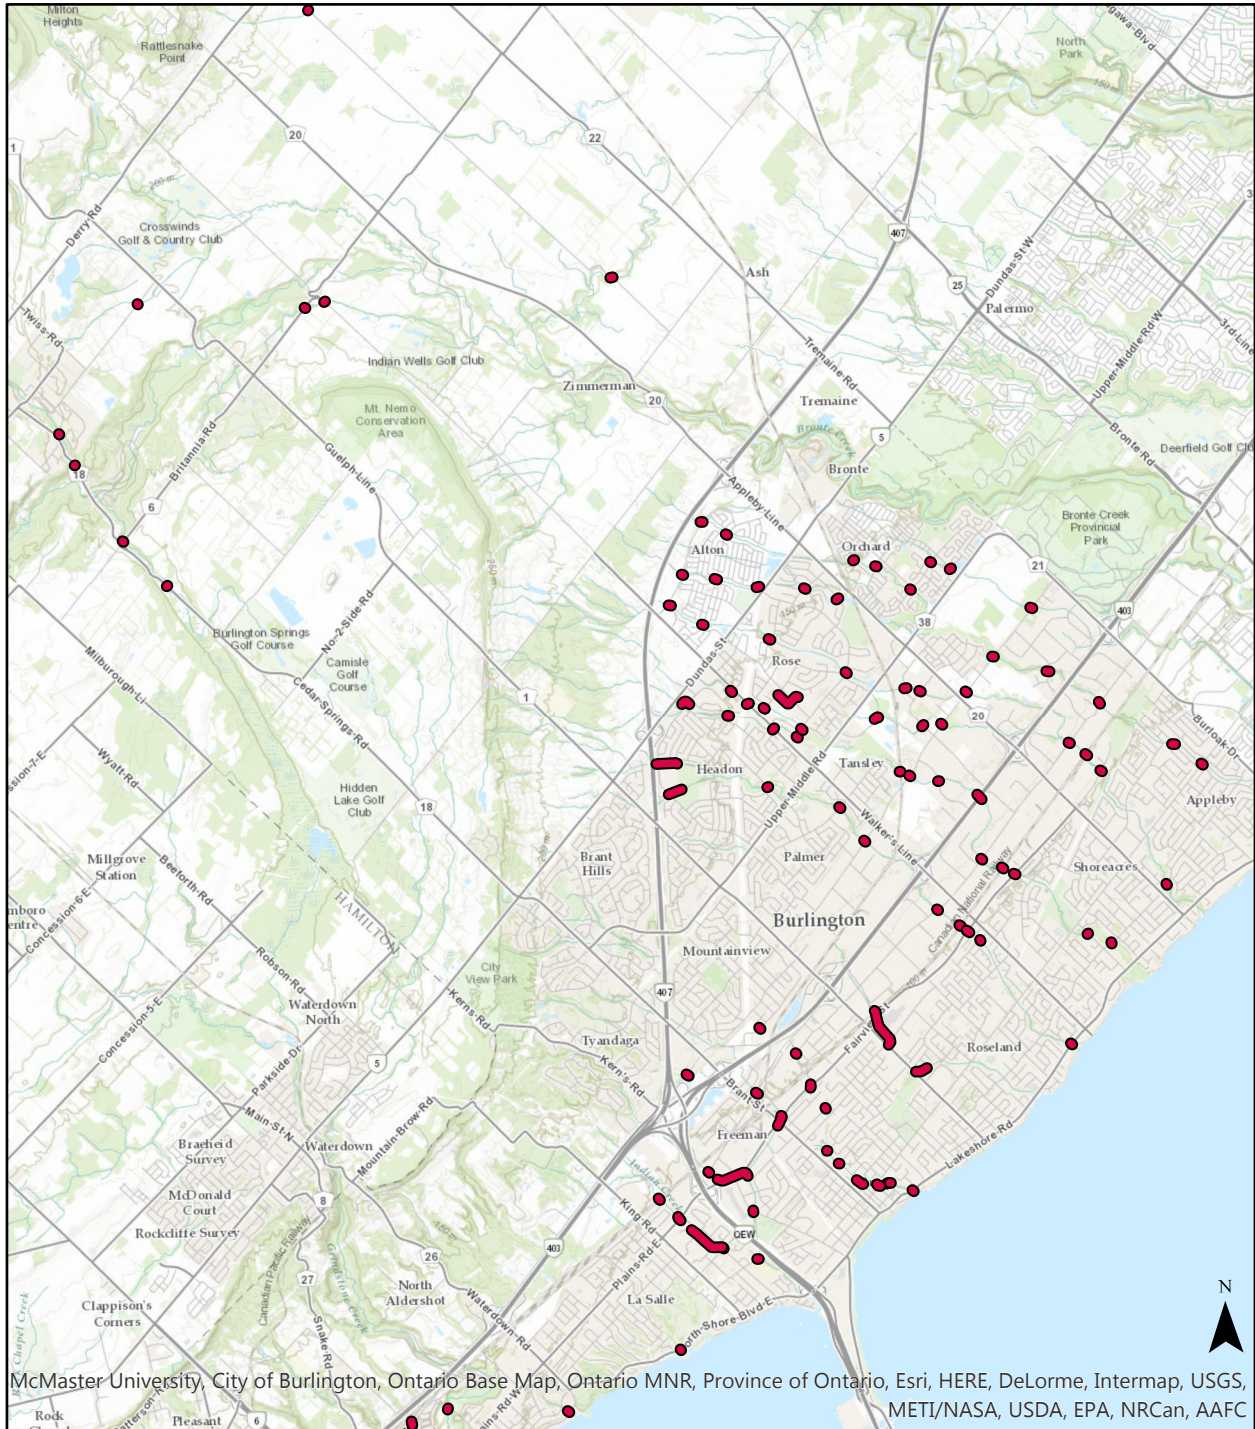
Asset ID: 5000

Condition: Poor

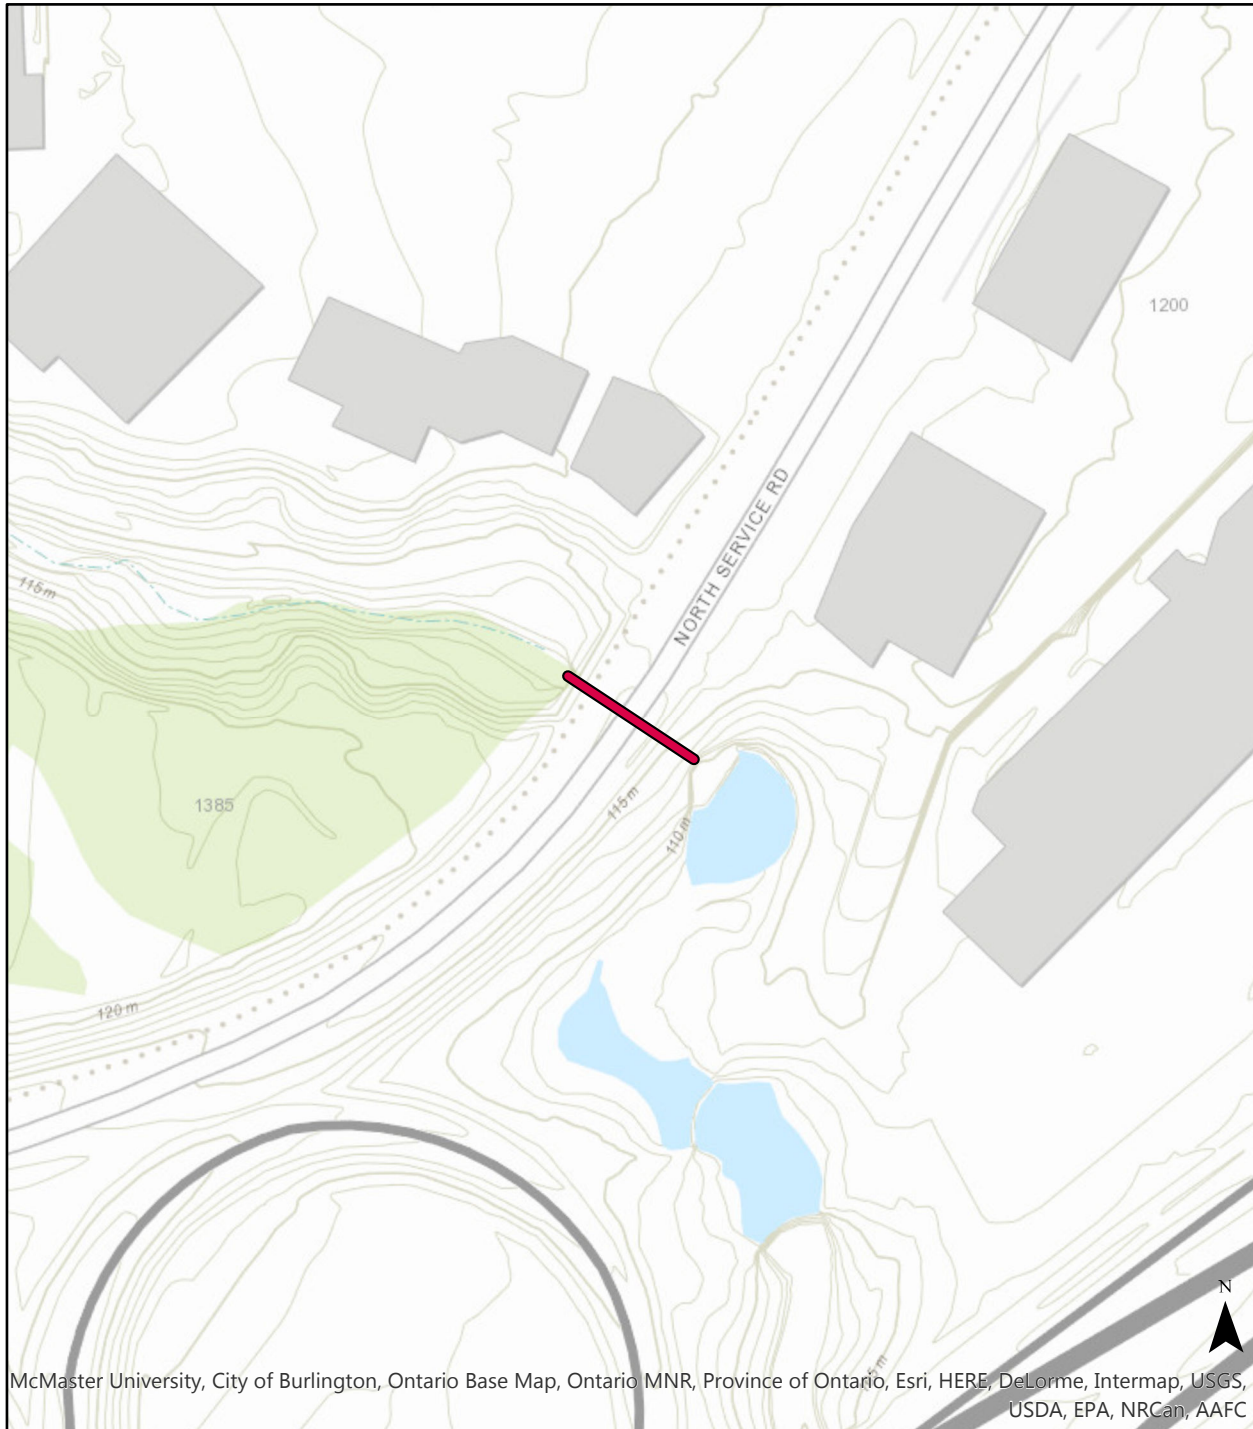
Asset ID: 5002

Condition: Poor

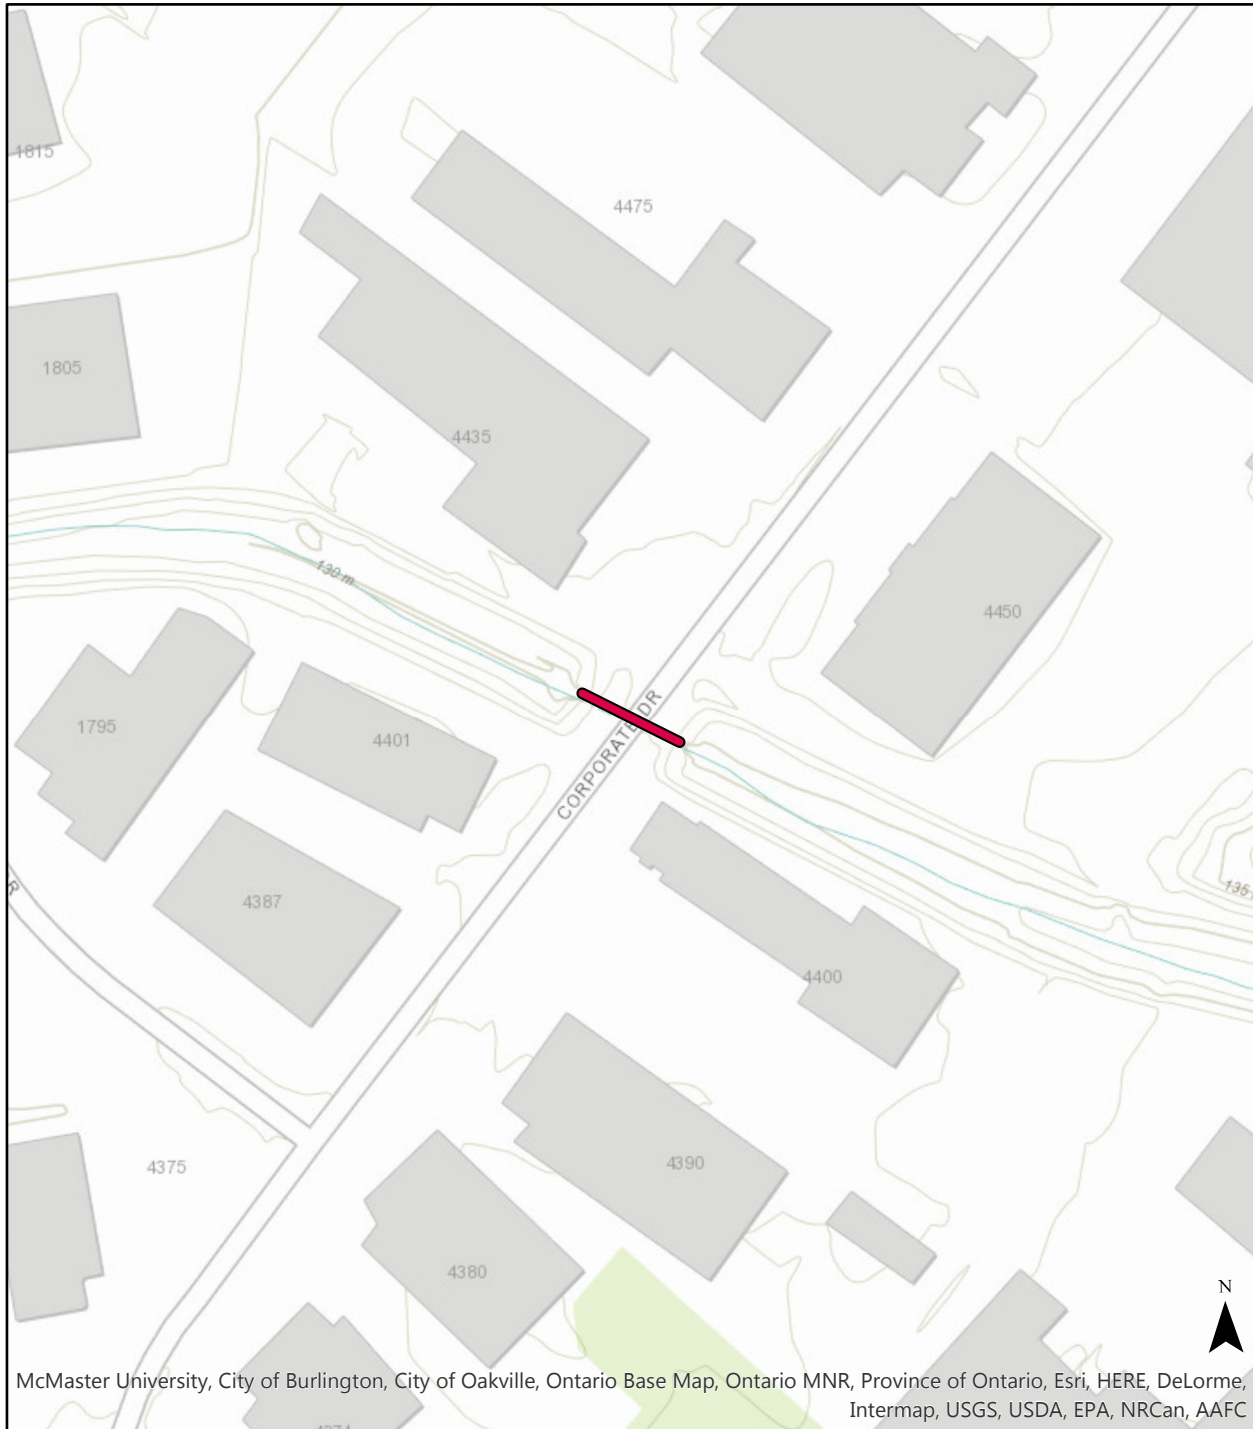
Asset ID: 5004

Condition: Bad

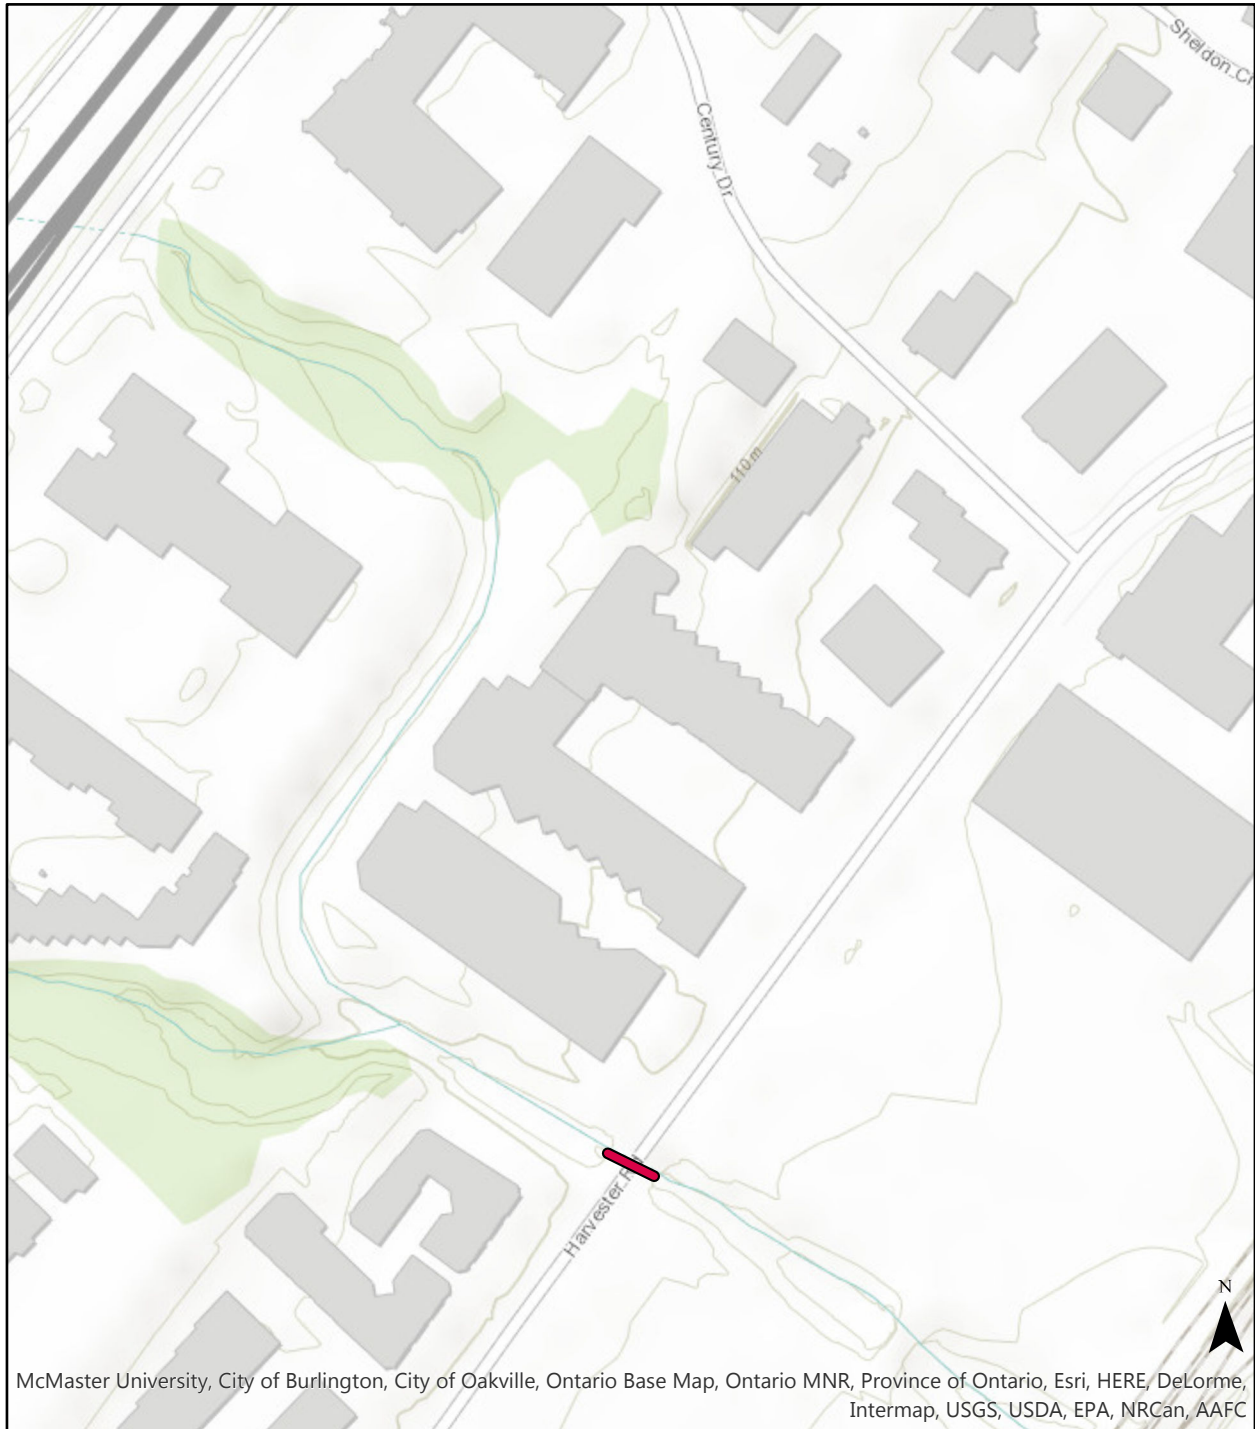
Asset ID: 5007

Condition: Good

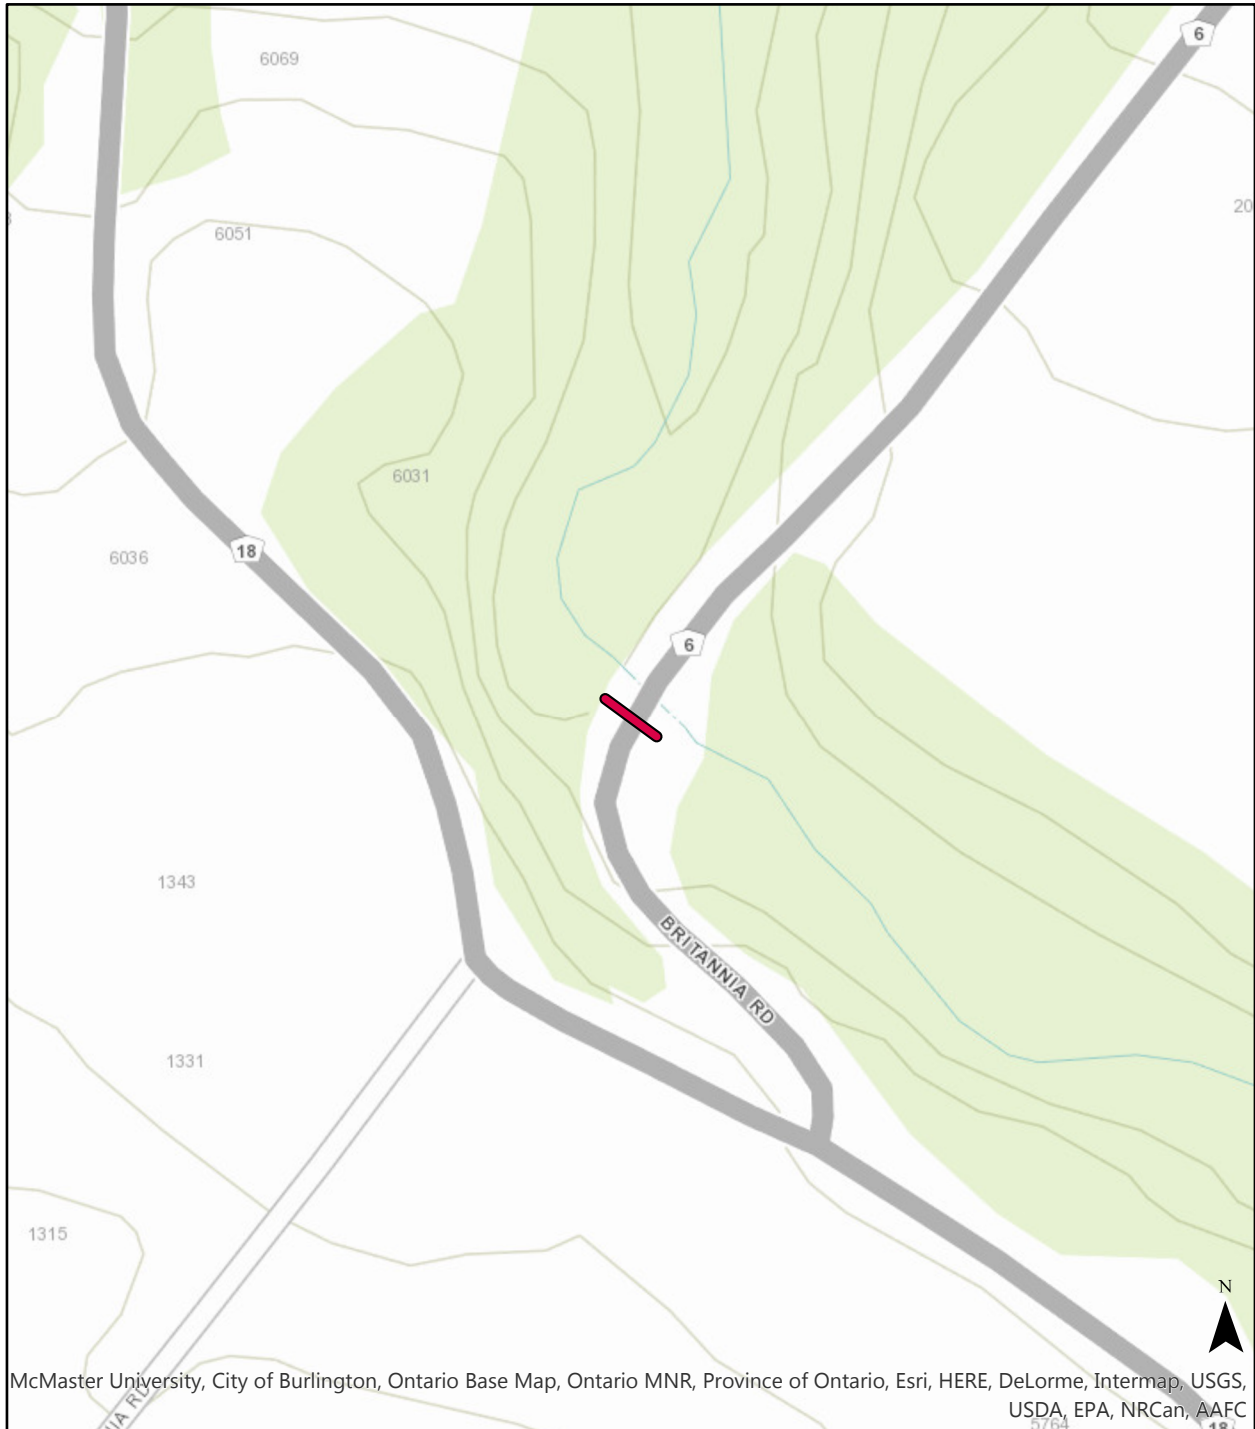
Asset ID: 5008

Condition: Fair

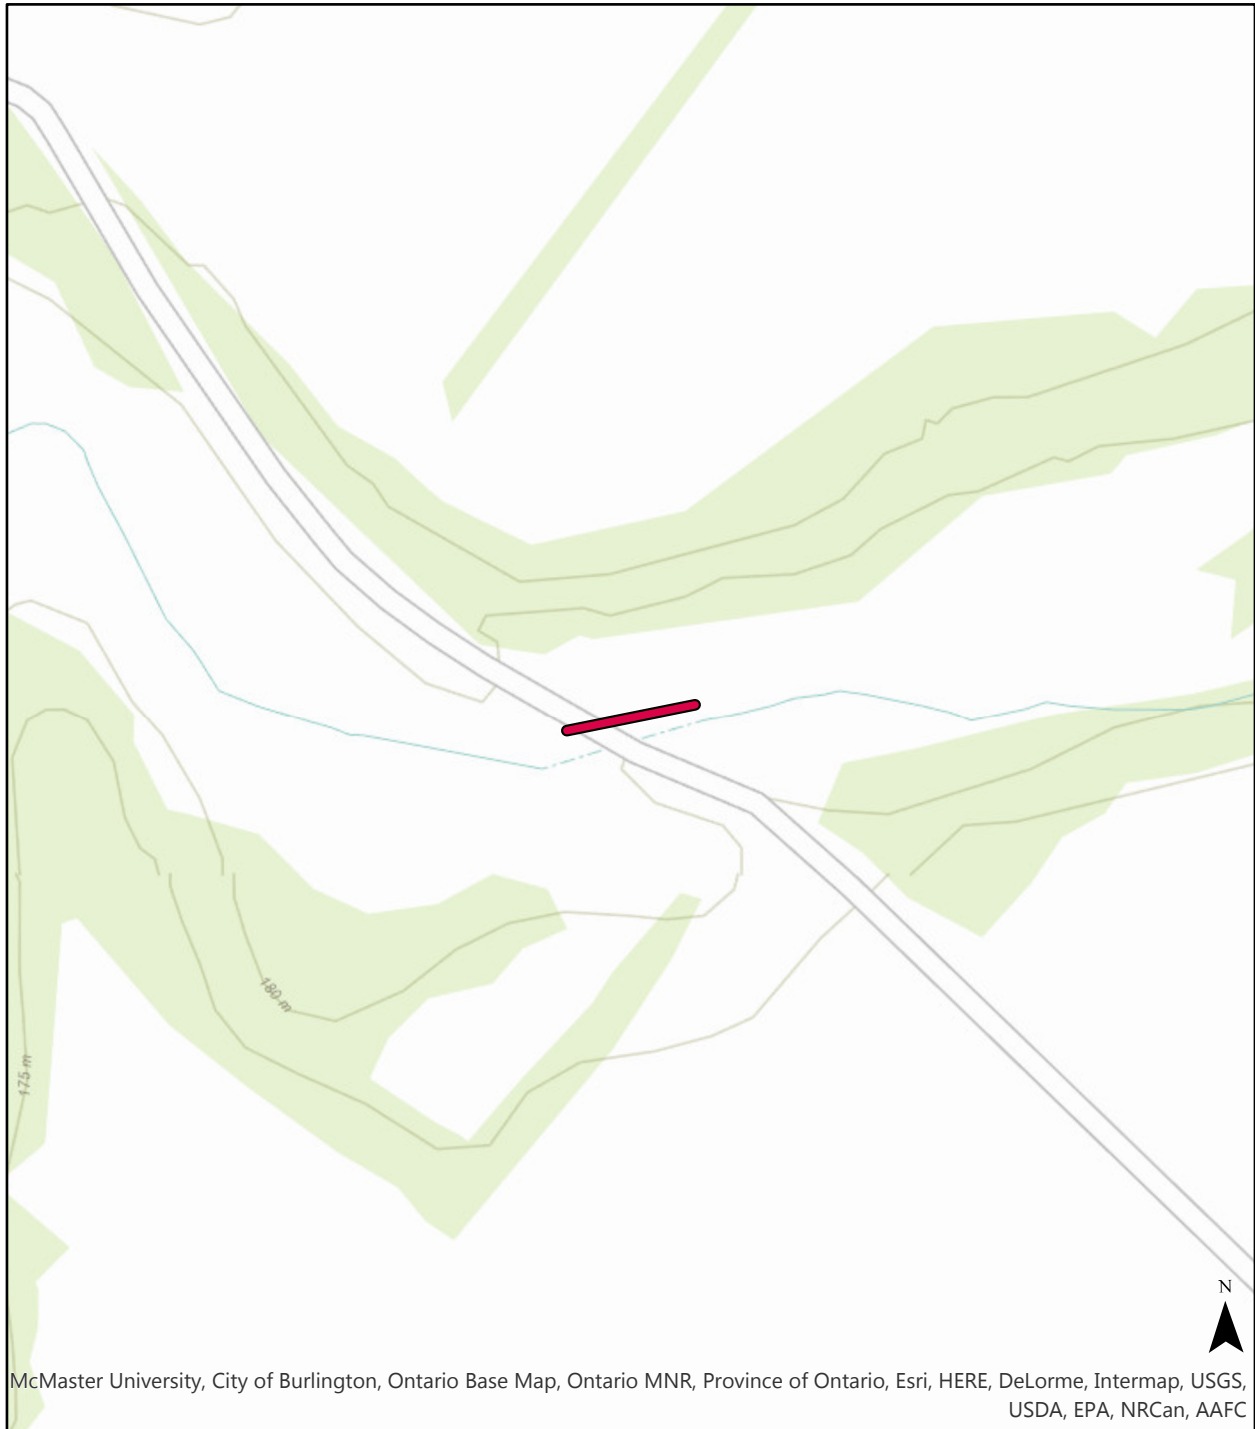
Asset ID: 5017

Condition: Fair

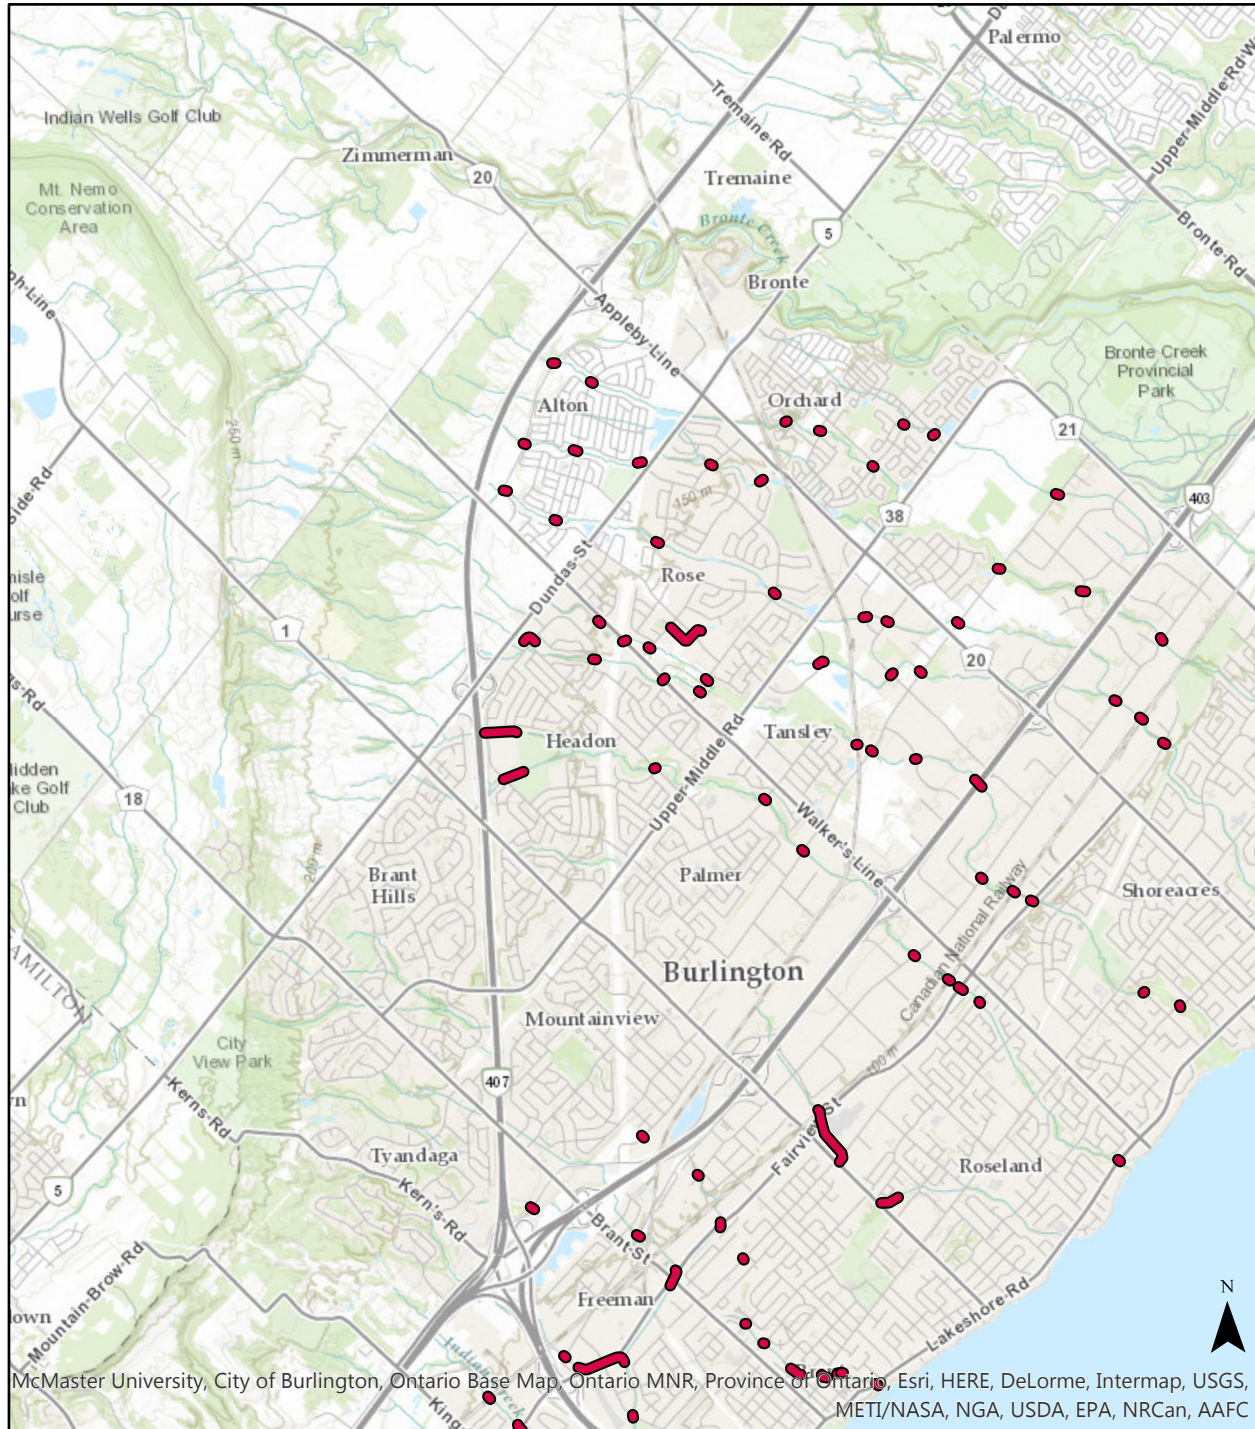
Asset ID: 5029

Condition: Bad

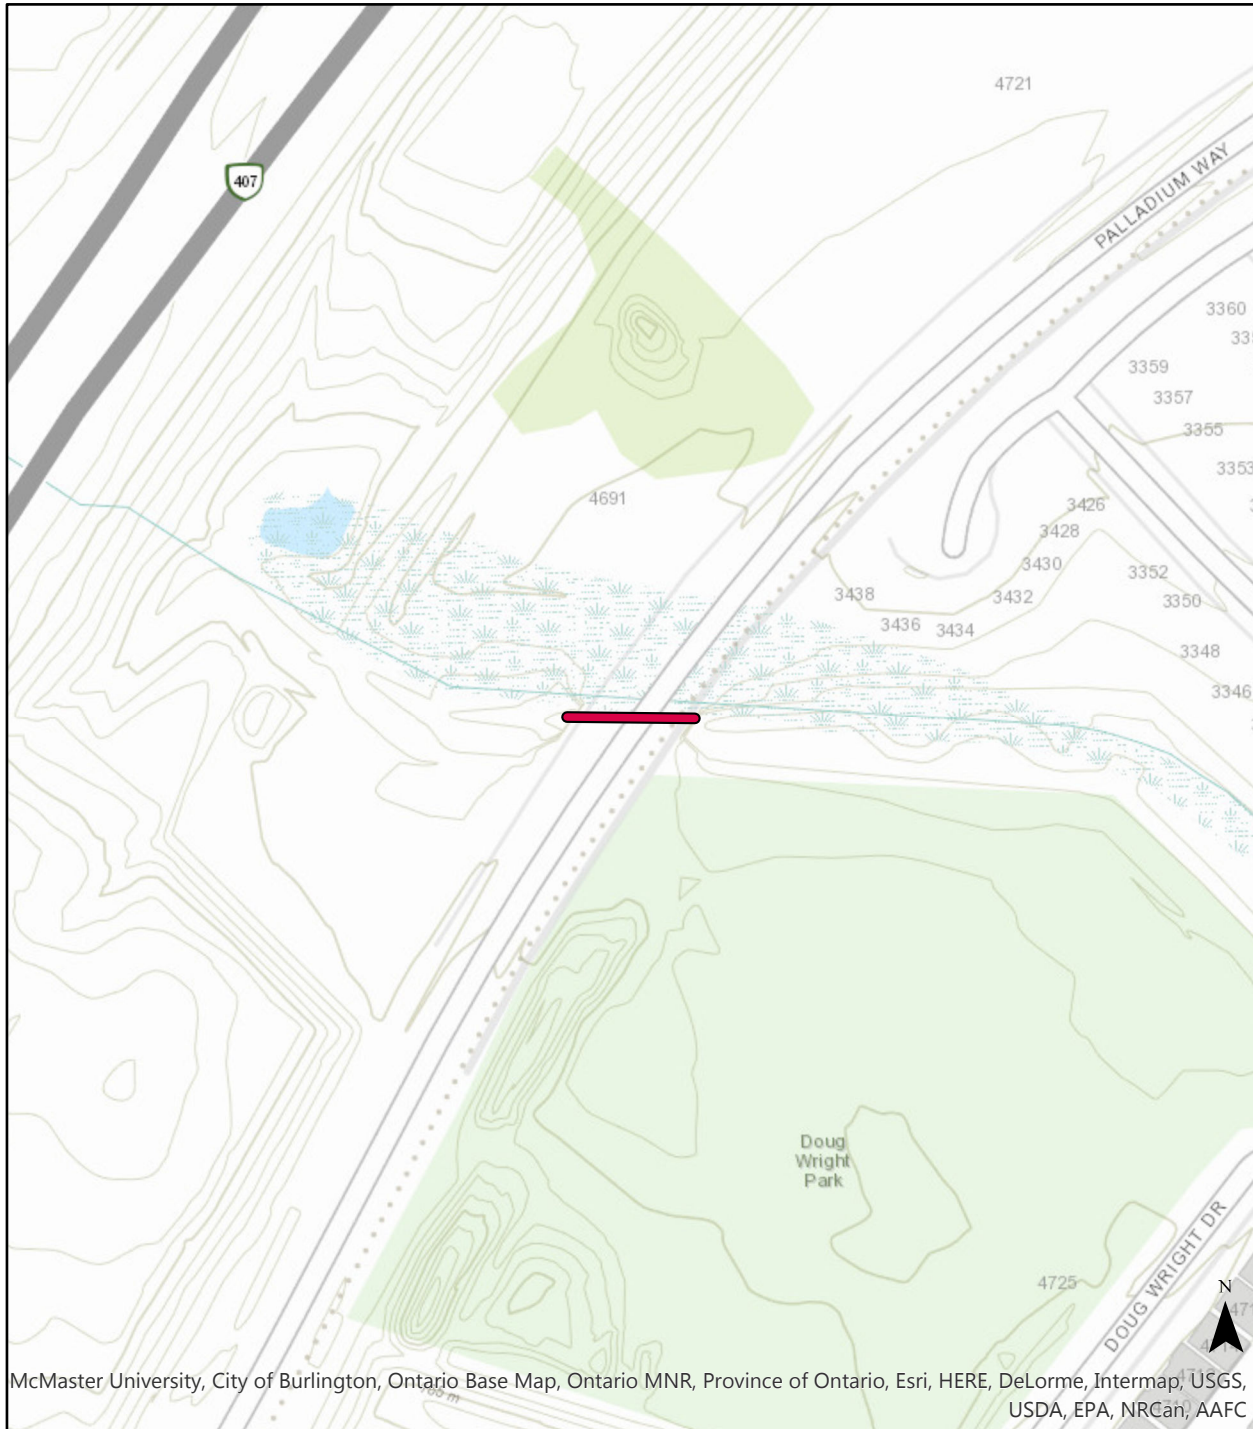
Asset ID: 5032

Condition: Poor

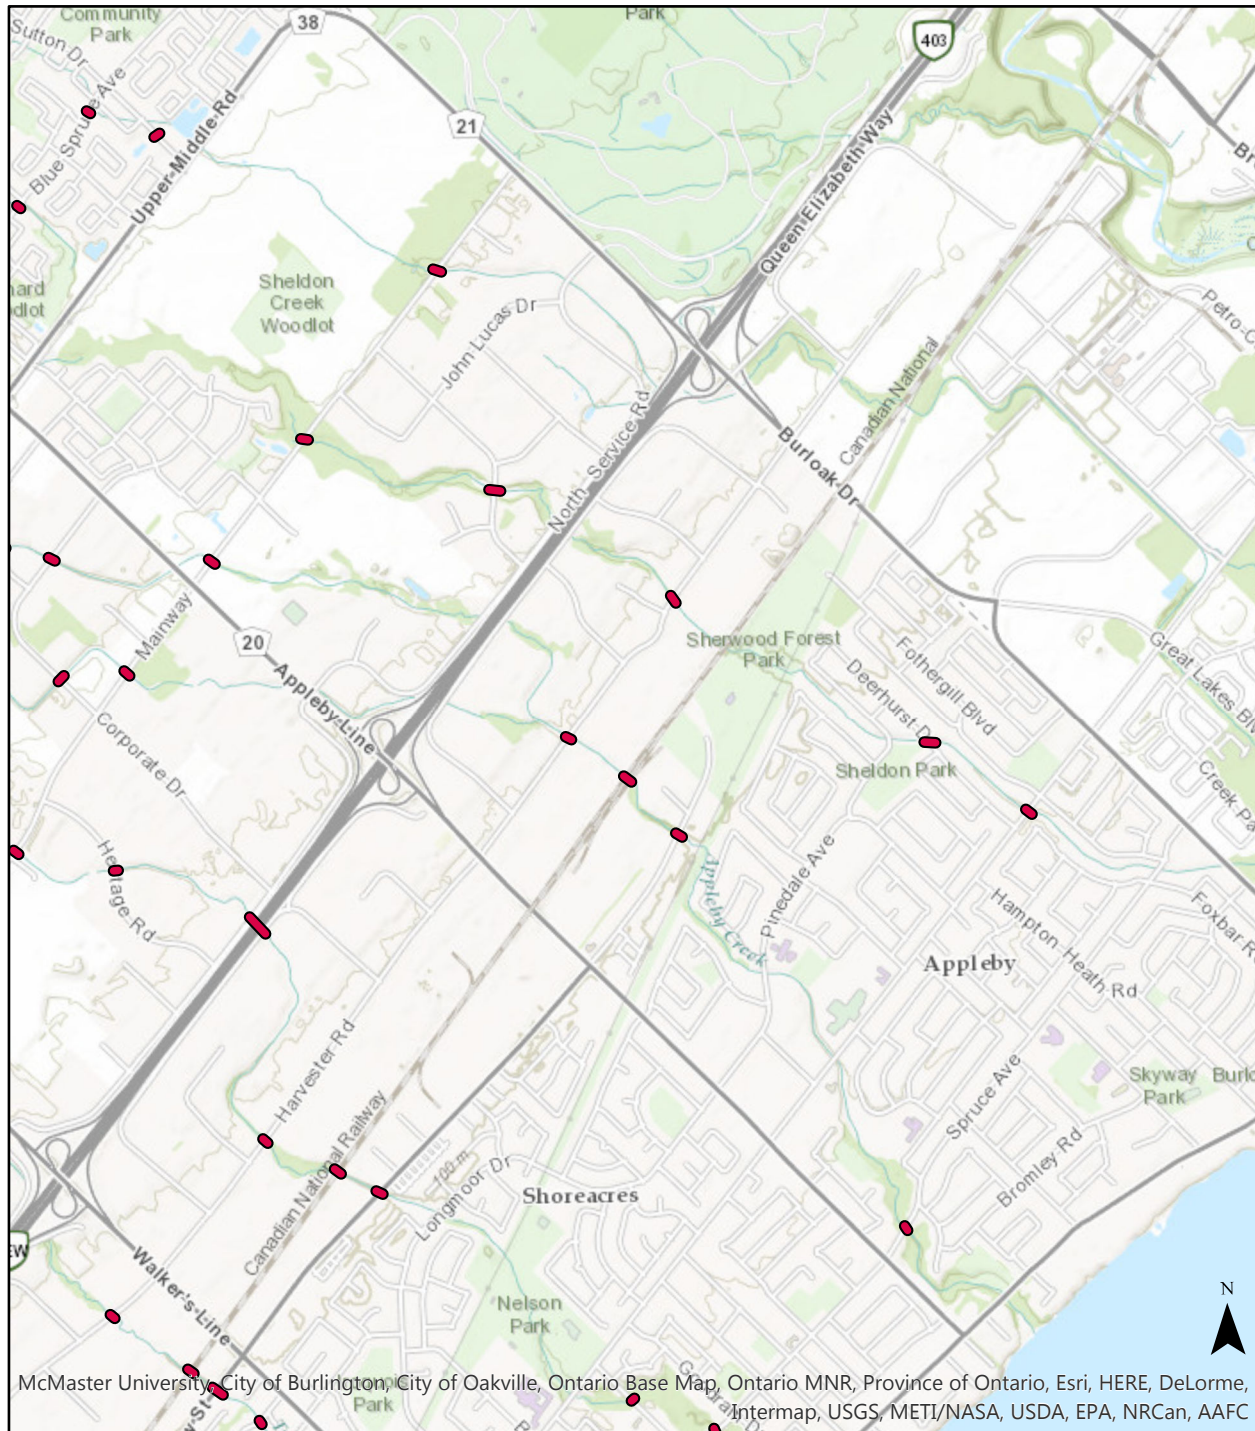
Asset ID: 5036

Condition: Poor

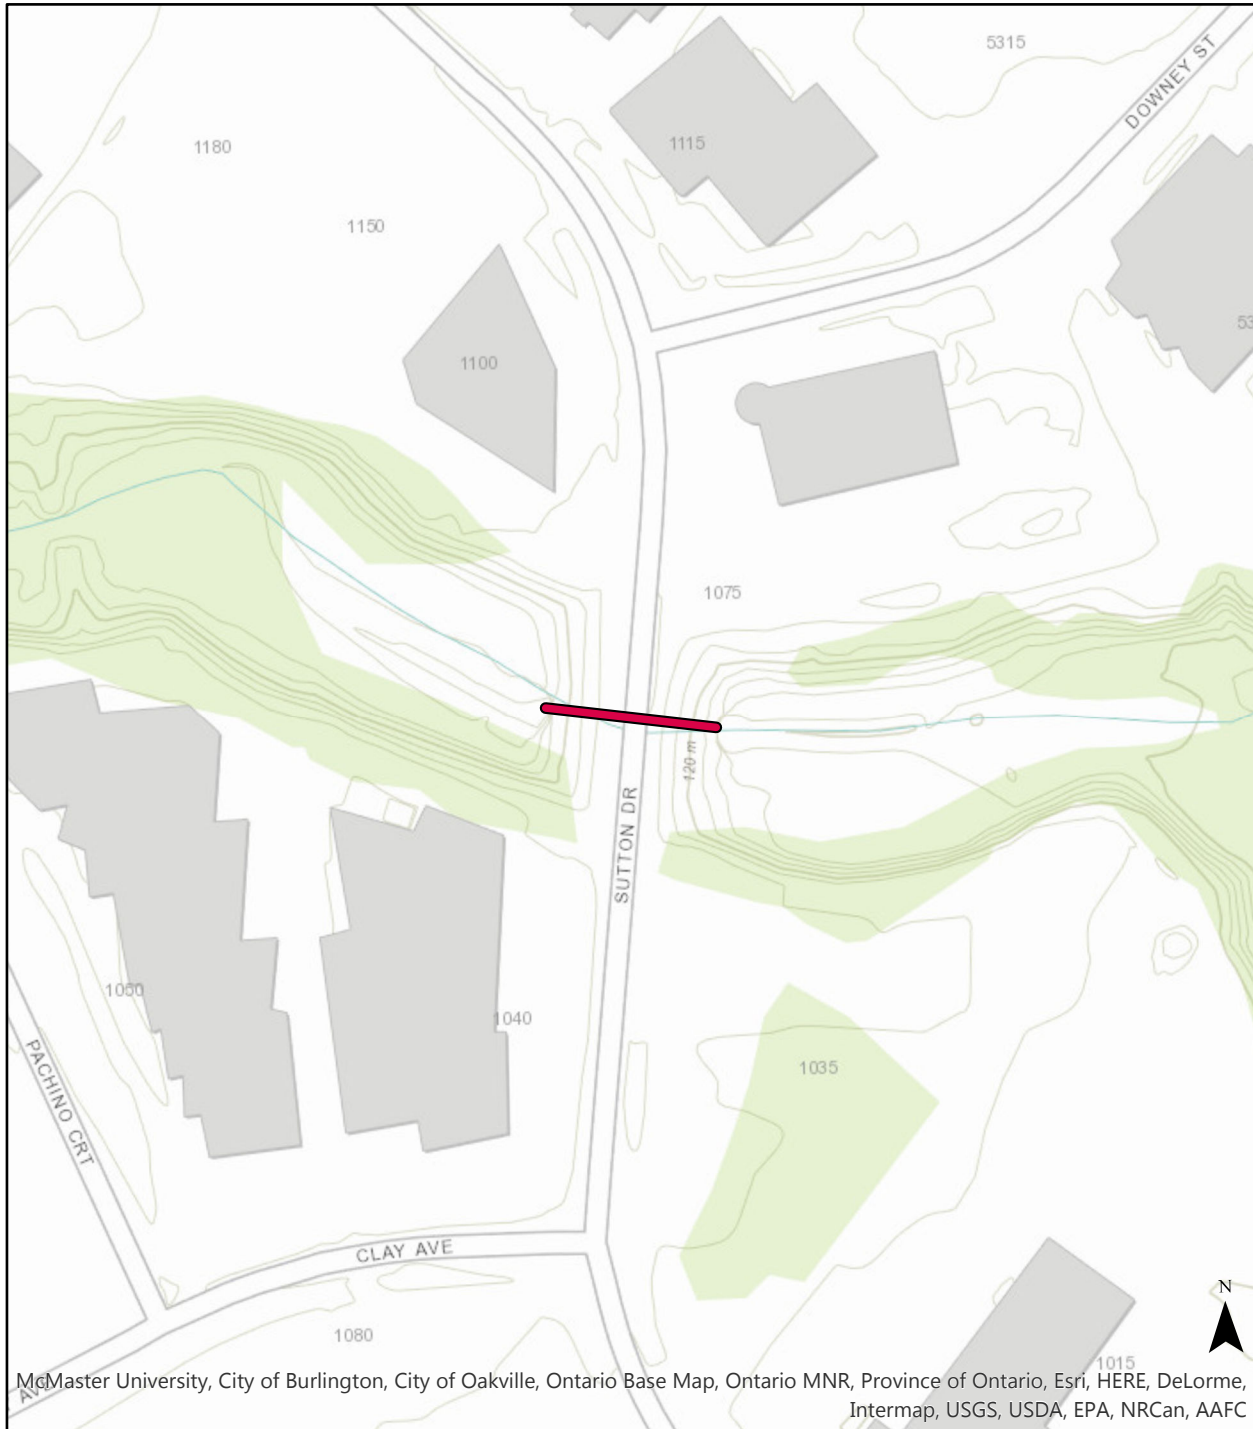
Asset ID: 5042

Condition: Bad

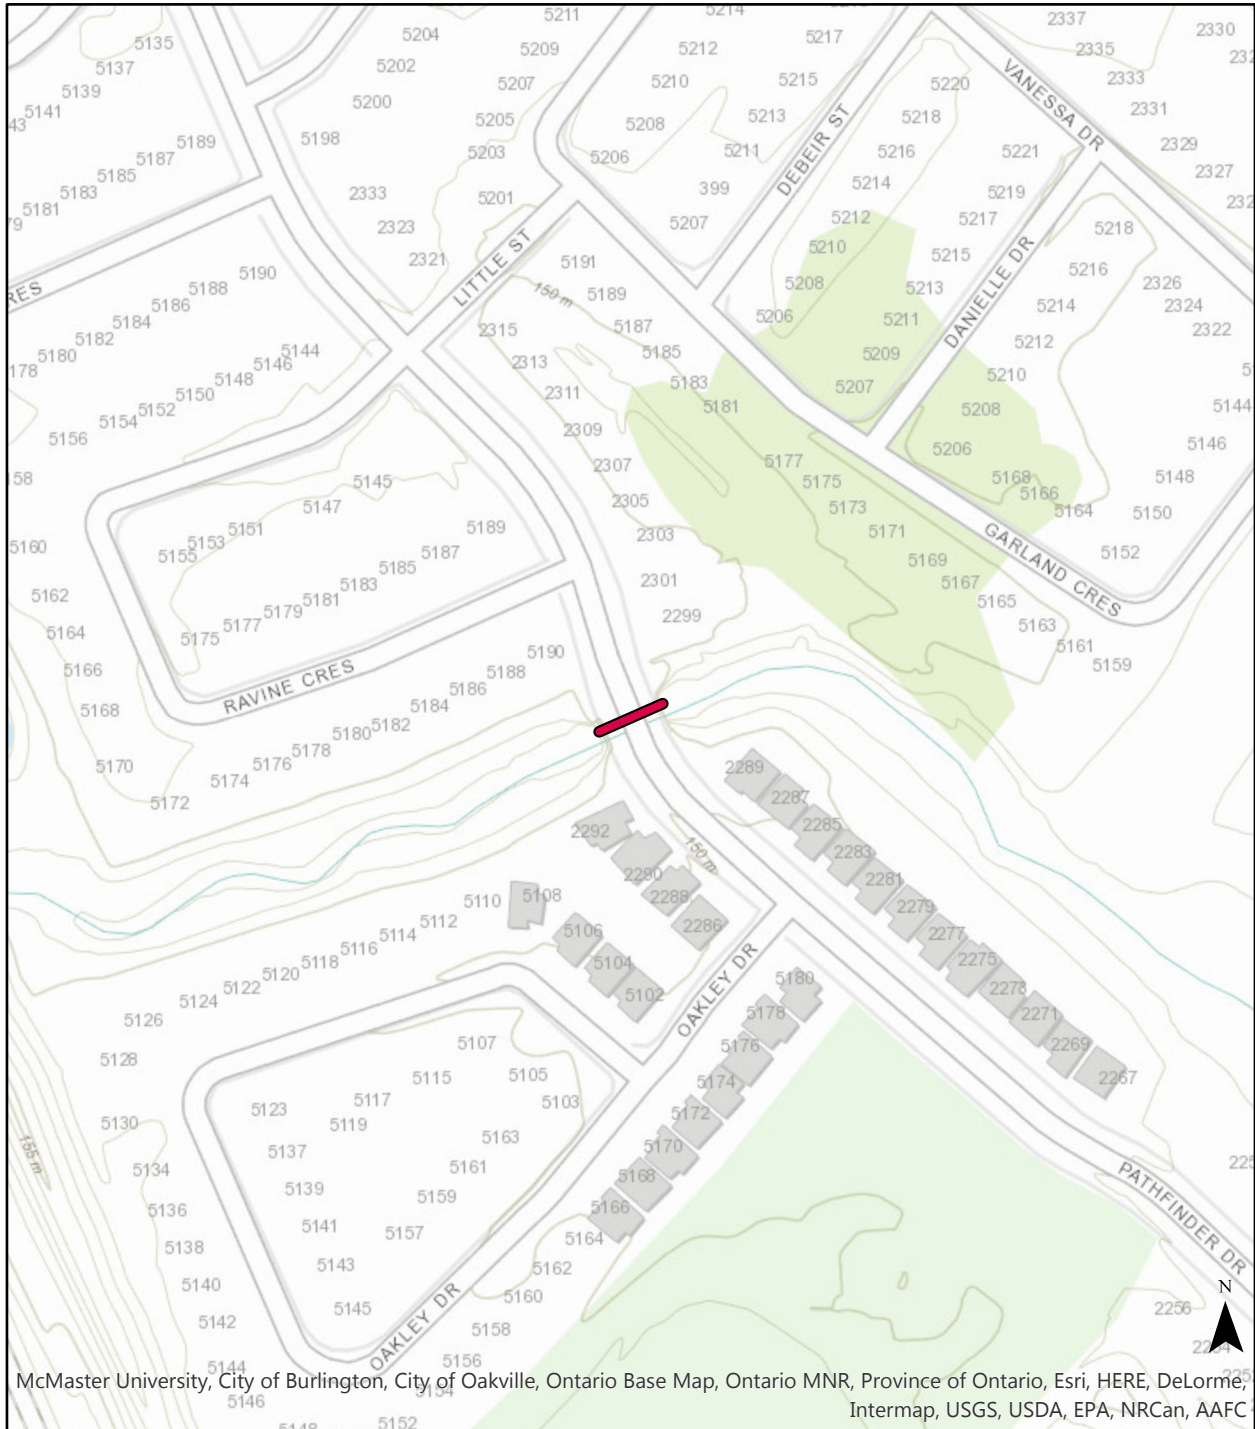
Asset ID: 5045

Condition: Poor

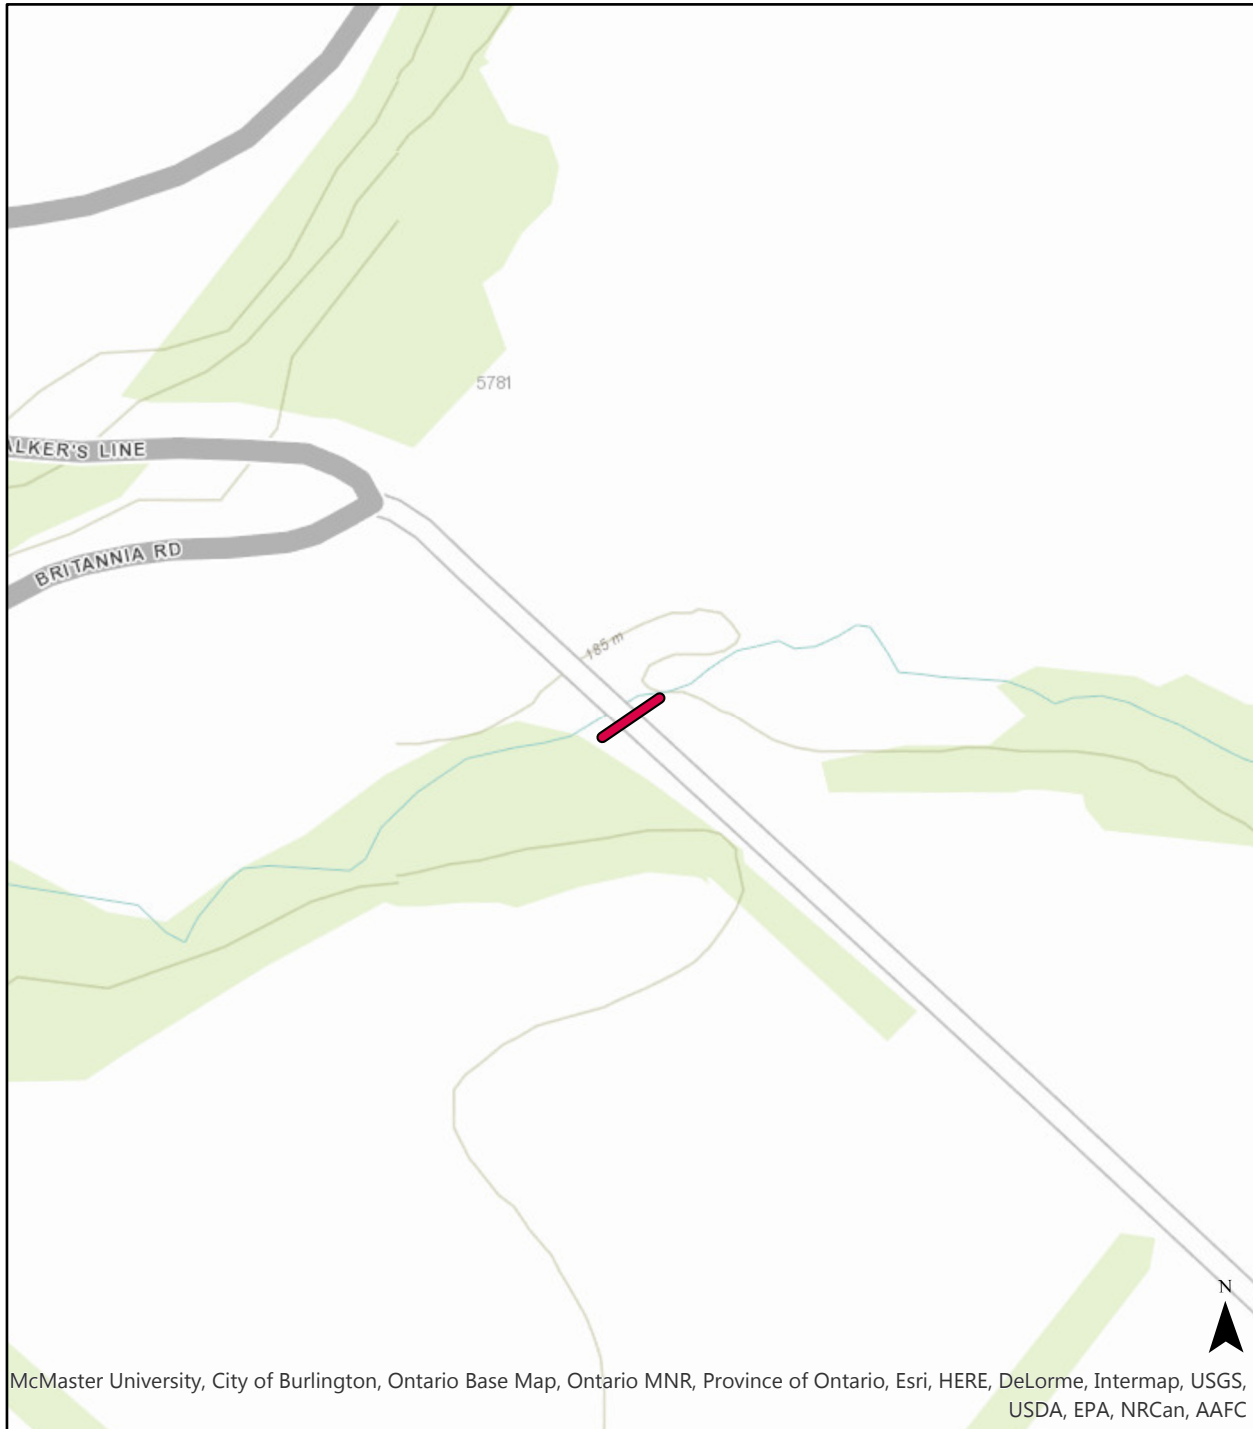
Asset ID: 5066

Condition: Poor

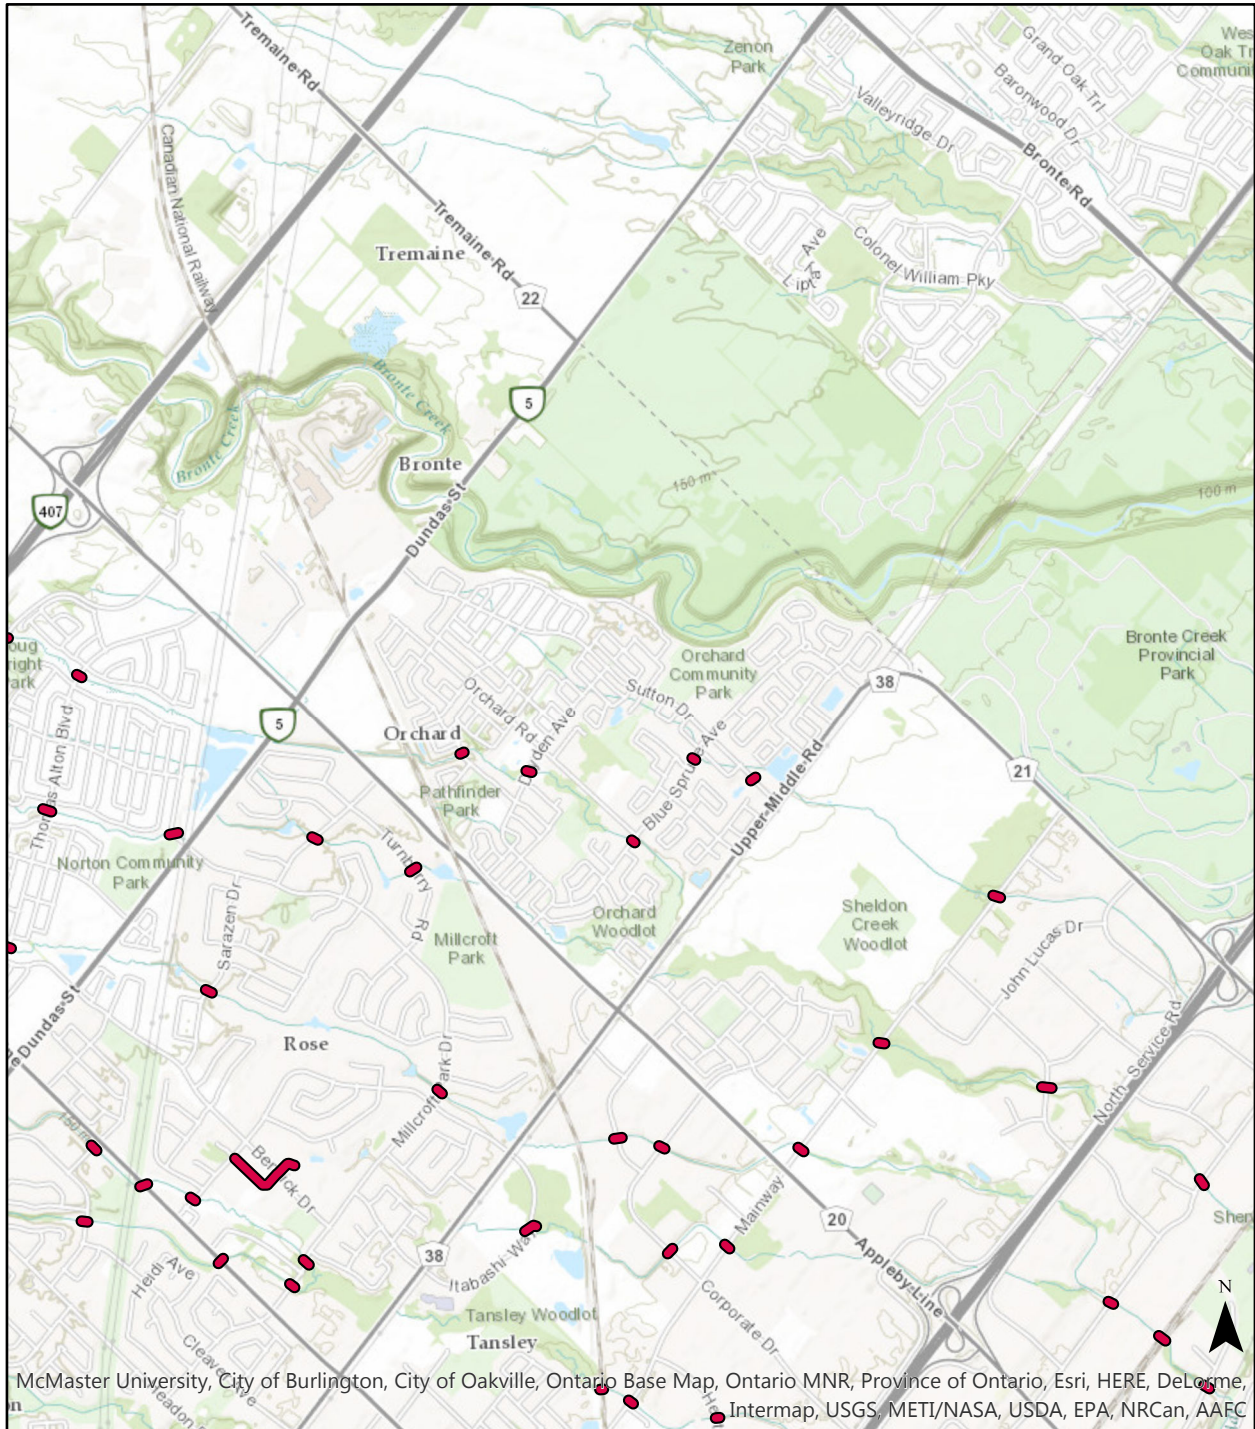
Asset ID: 5072

Condition: Poor
