Culvert Inspection

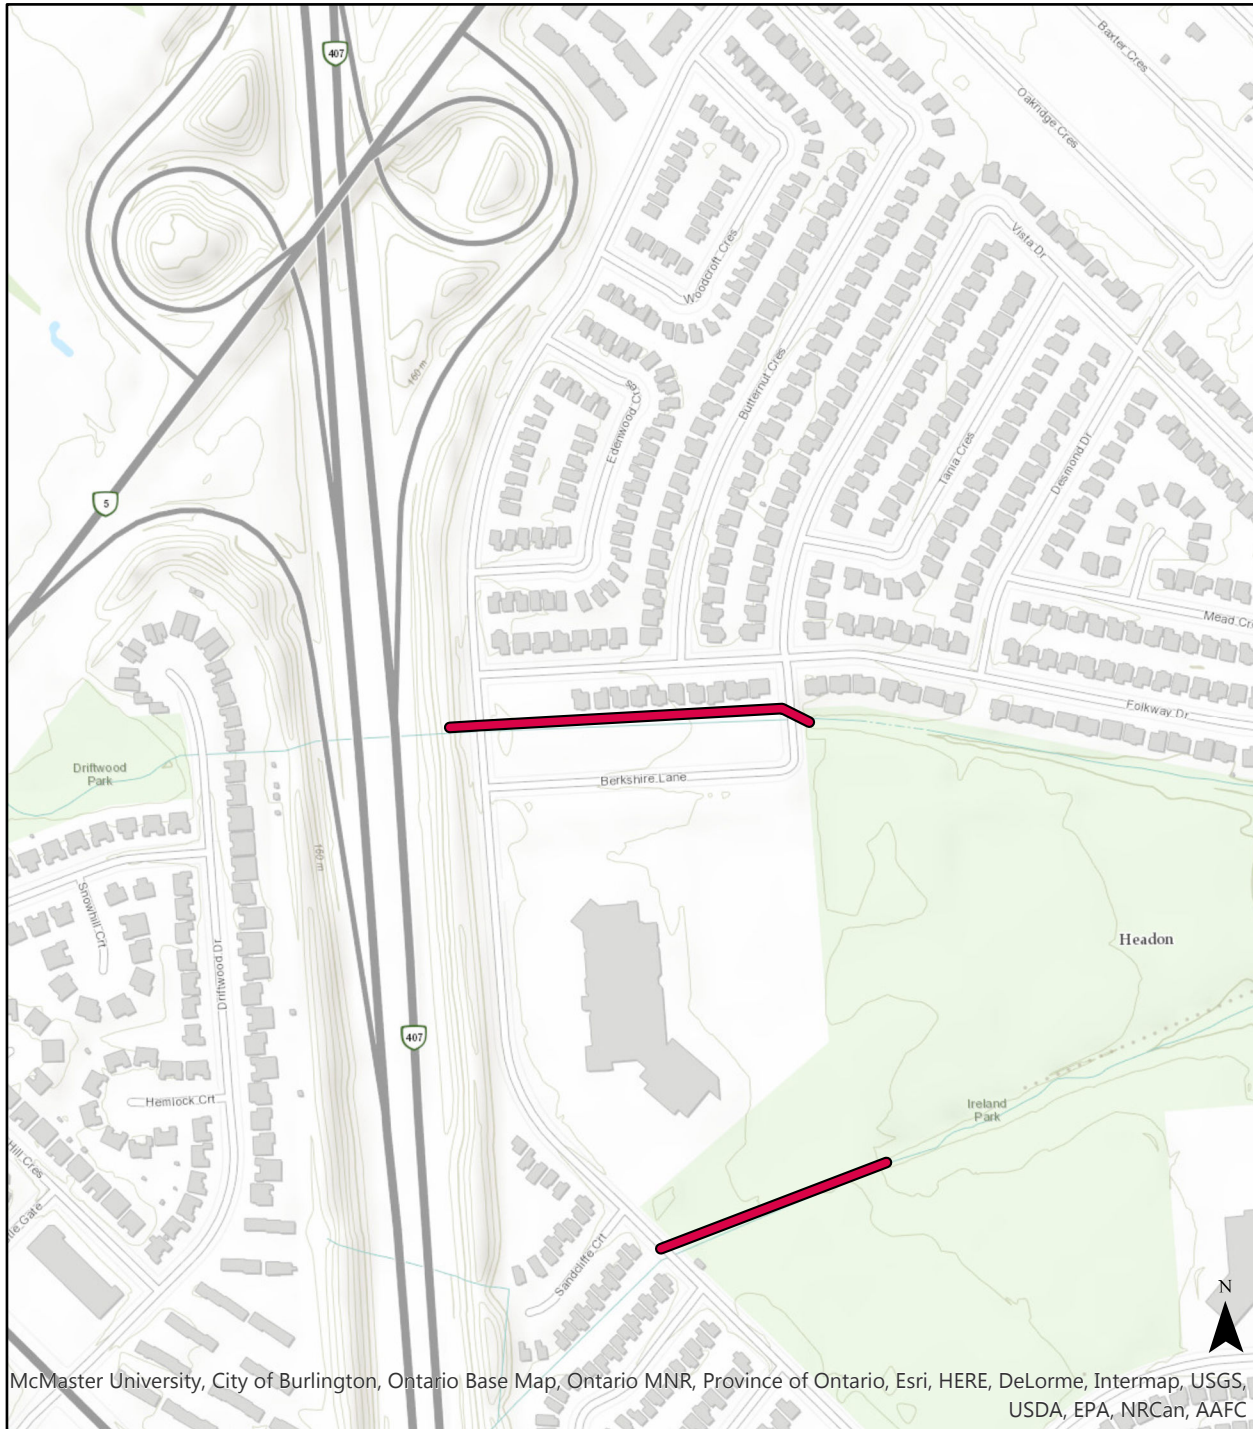
Asset ID: 5078

Condition: Fair

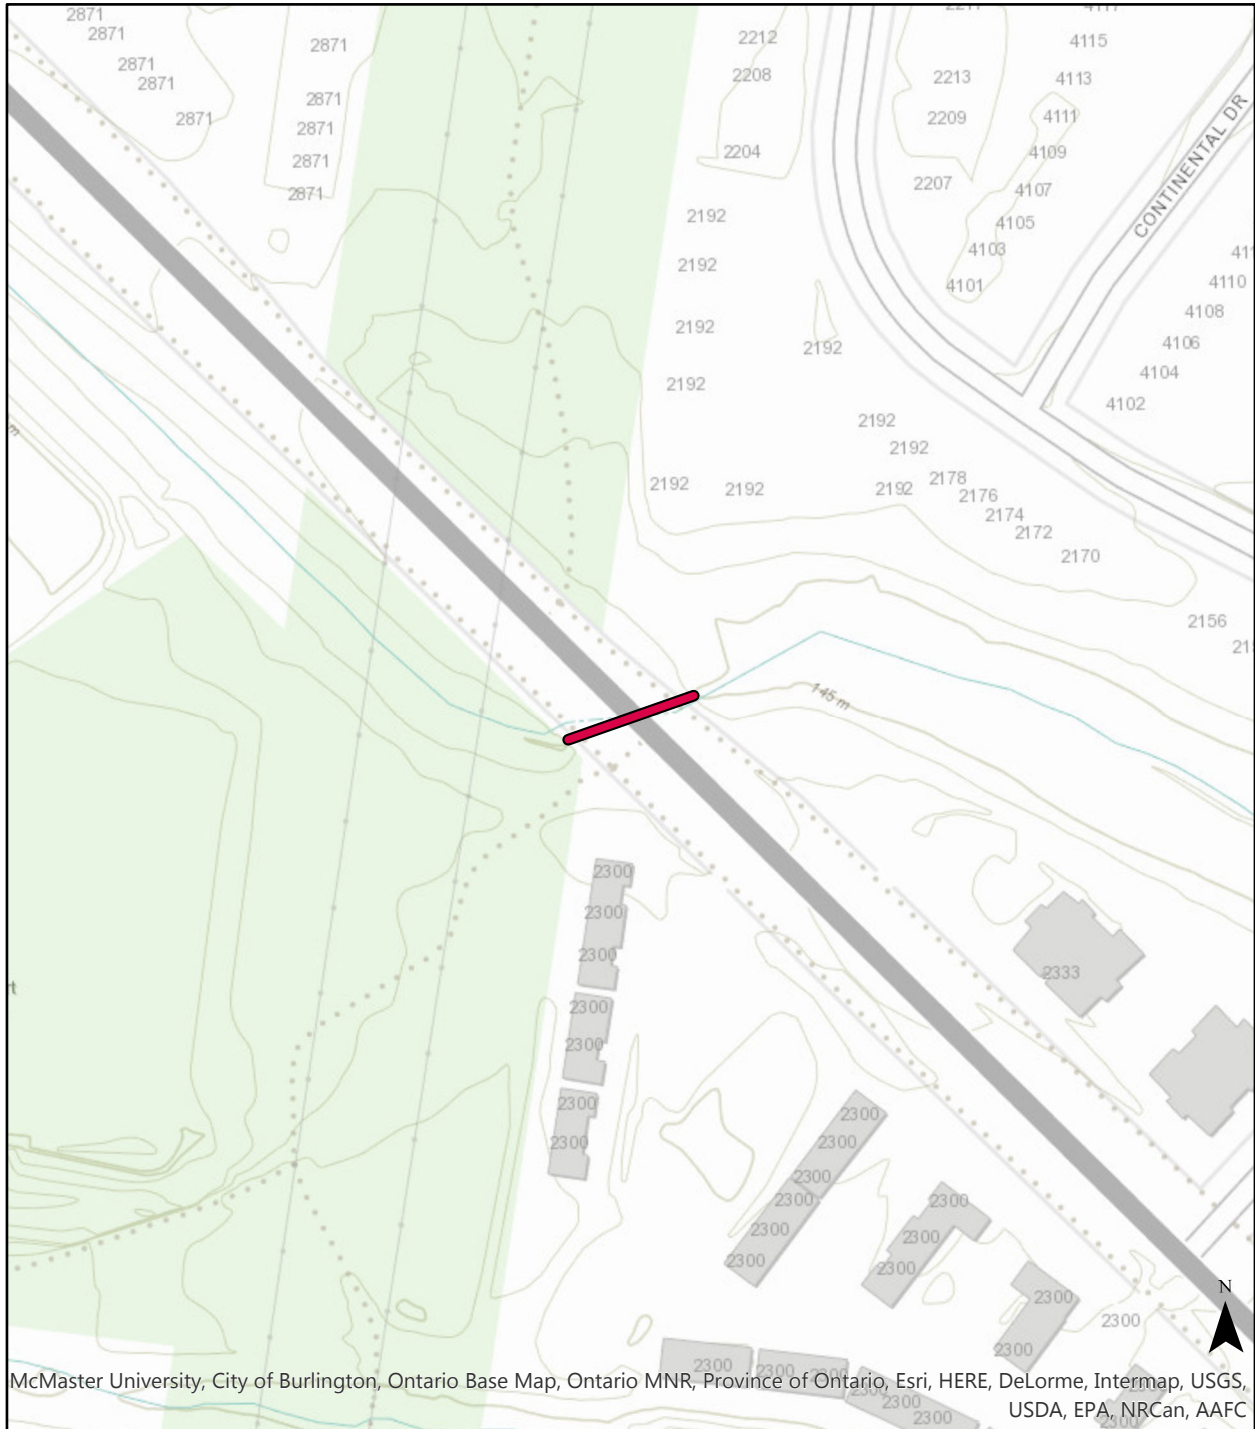
Asset ID: 5083

Condition: Good

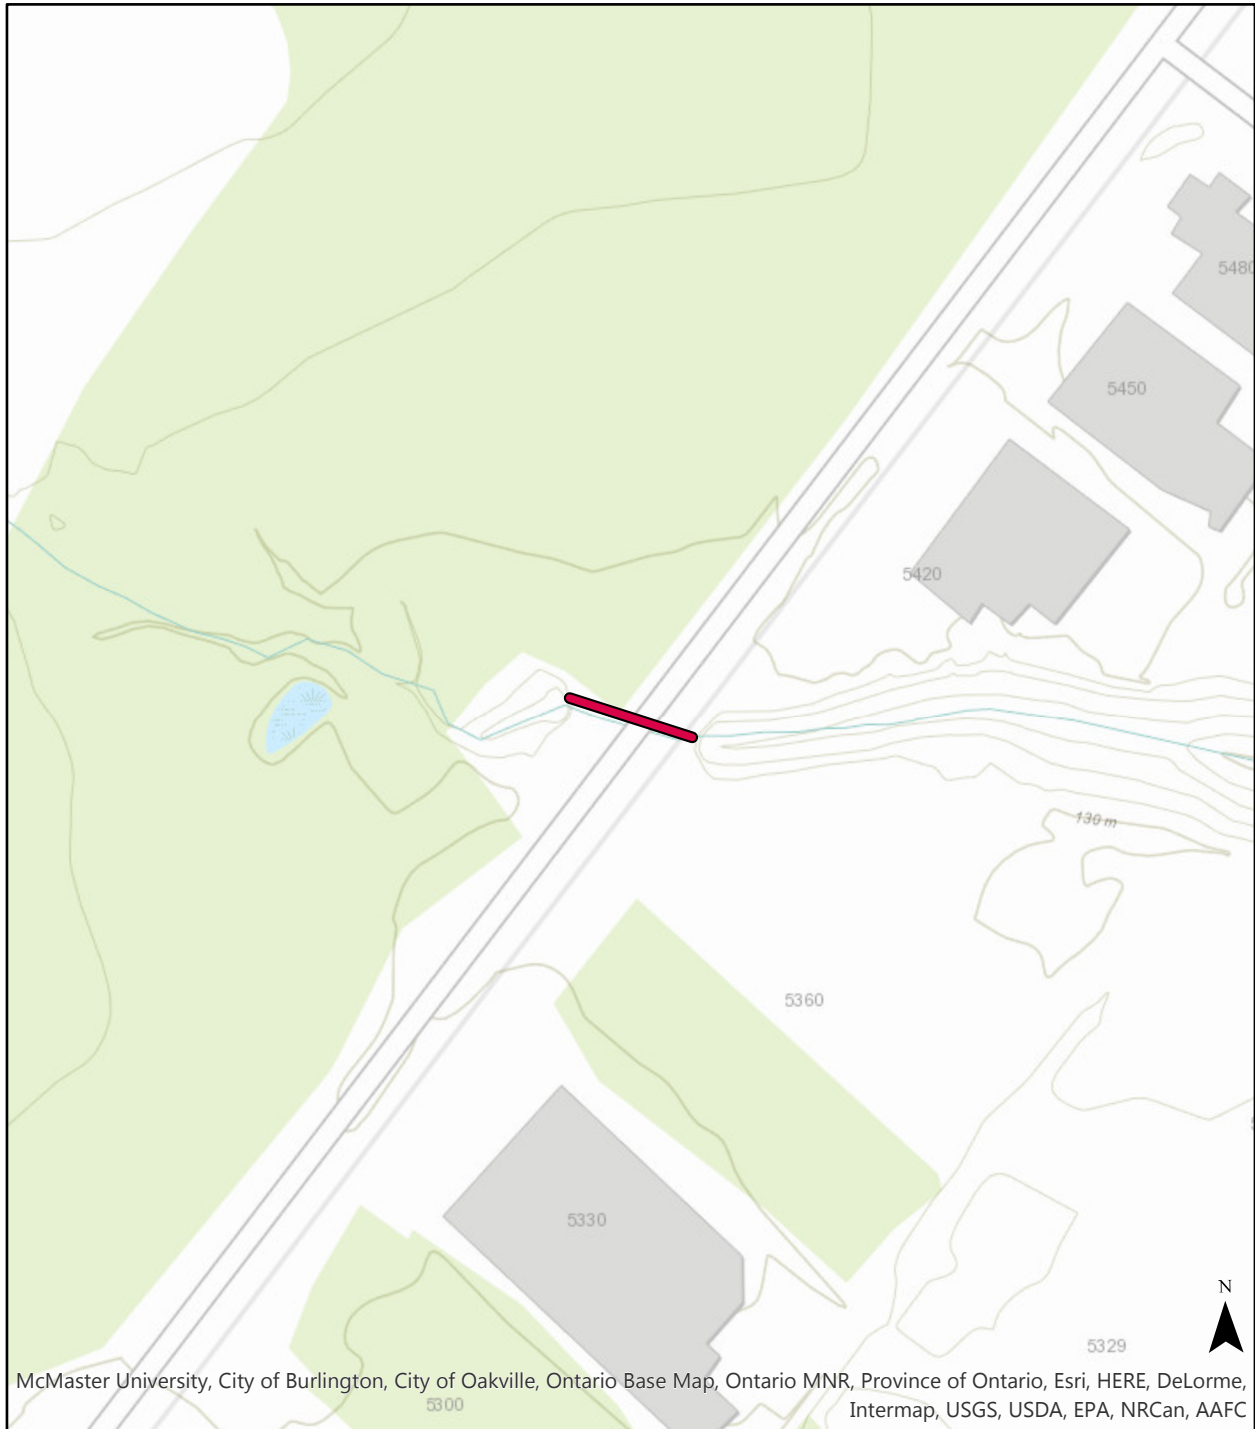
Asset ID: 5087

Condition: Fair

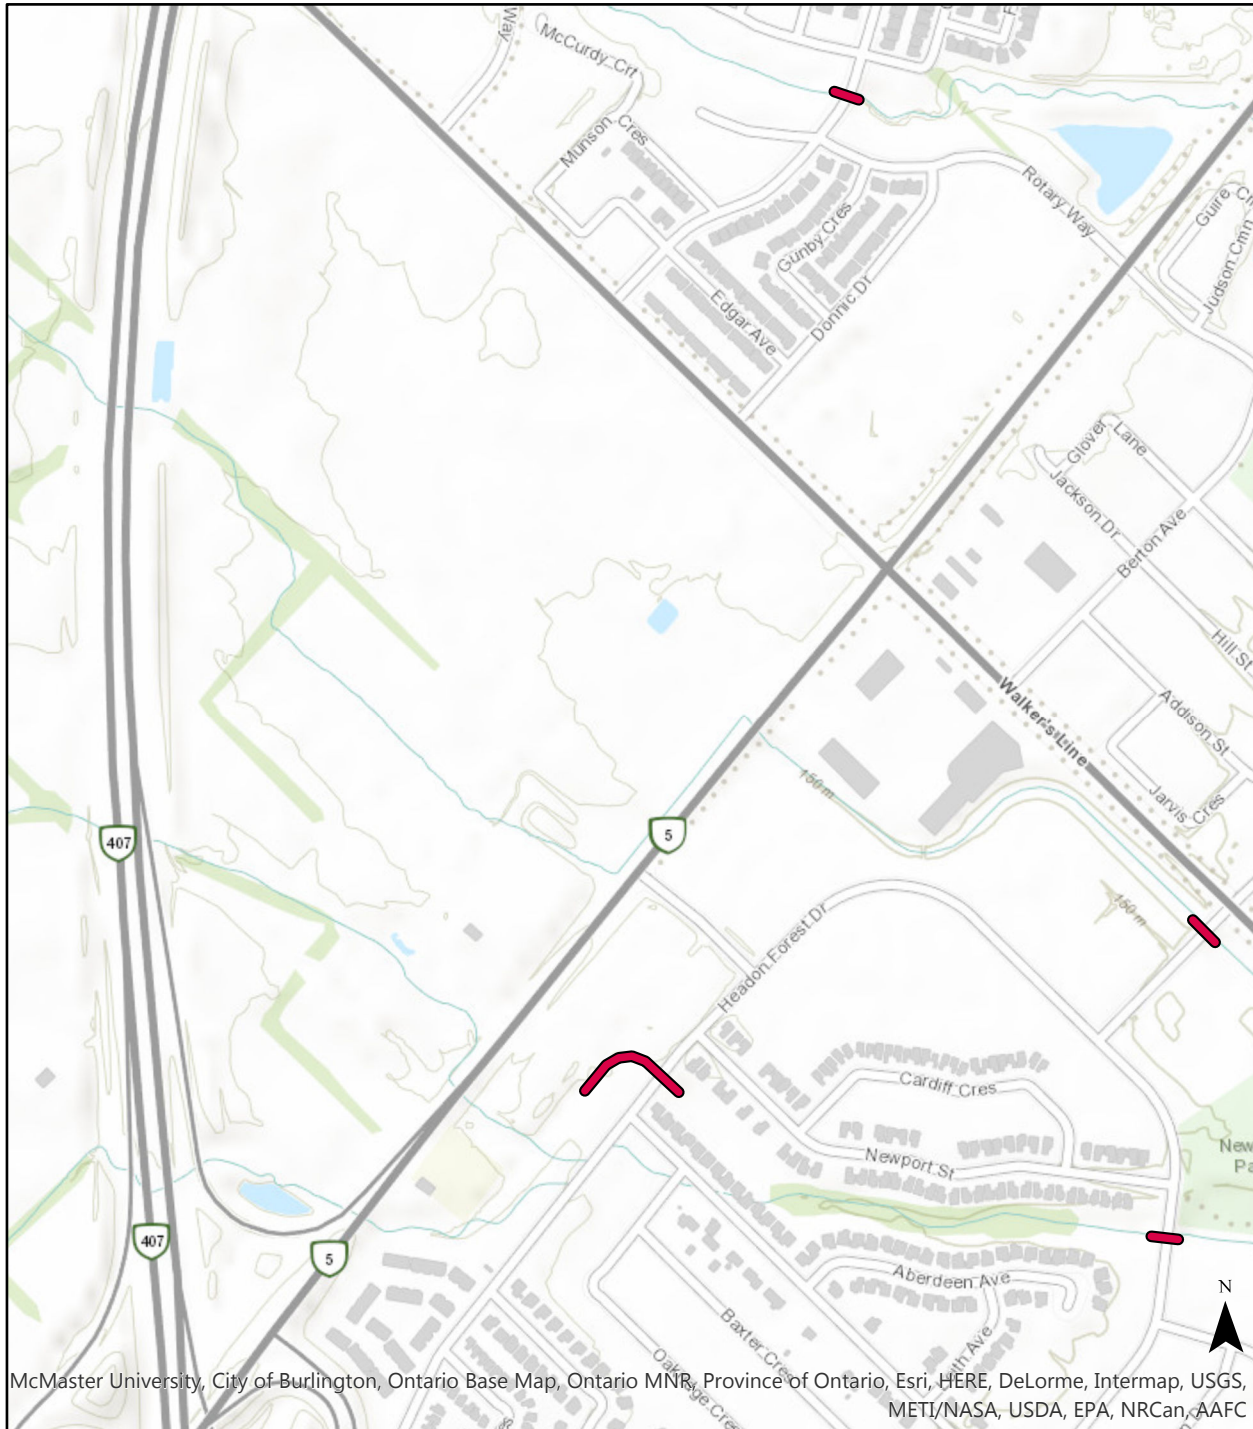
Asset ID: 5088

Condition: Very Good

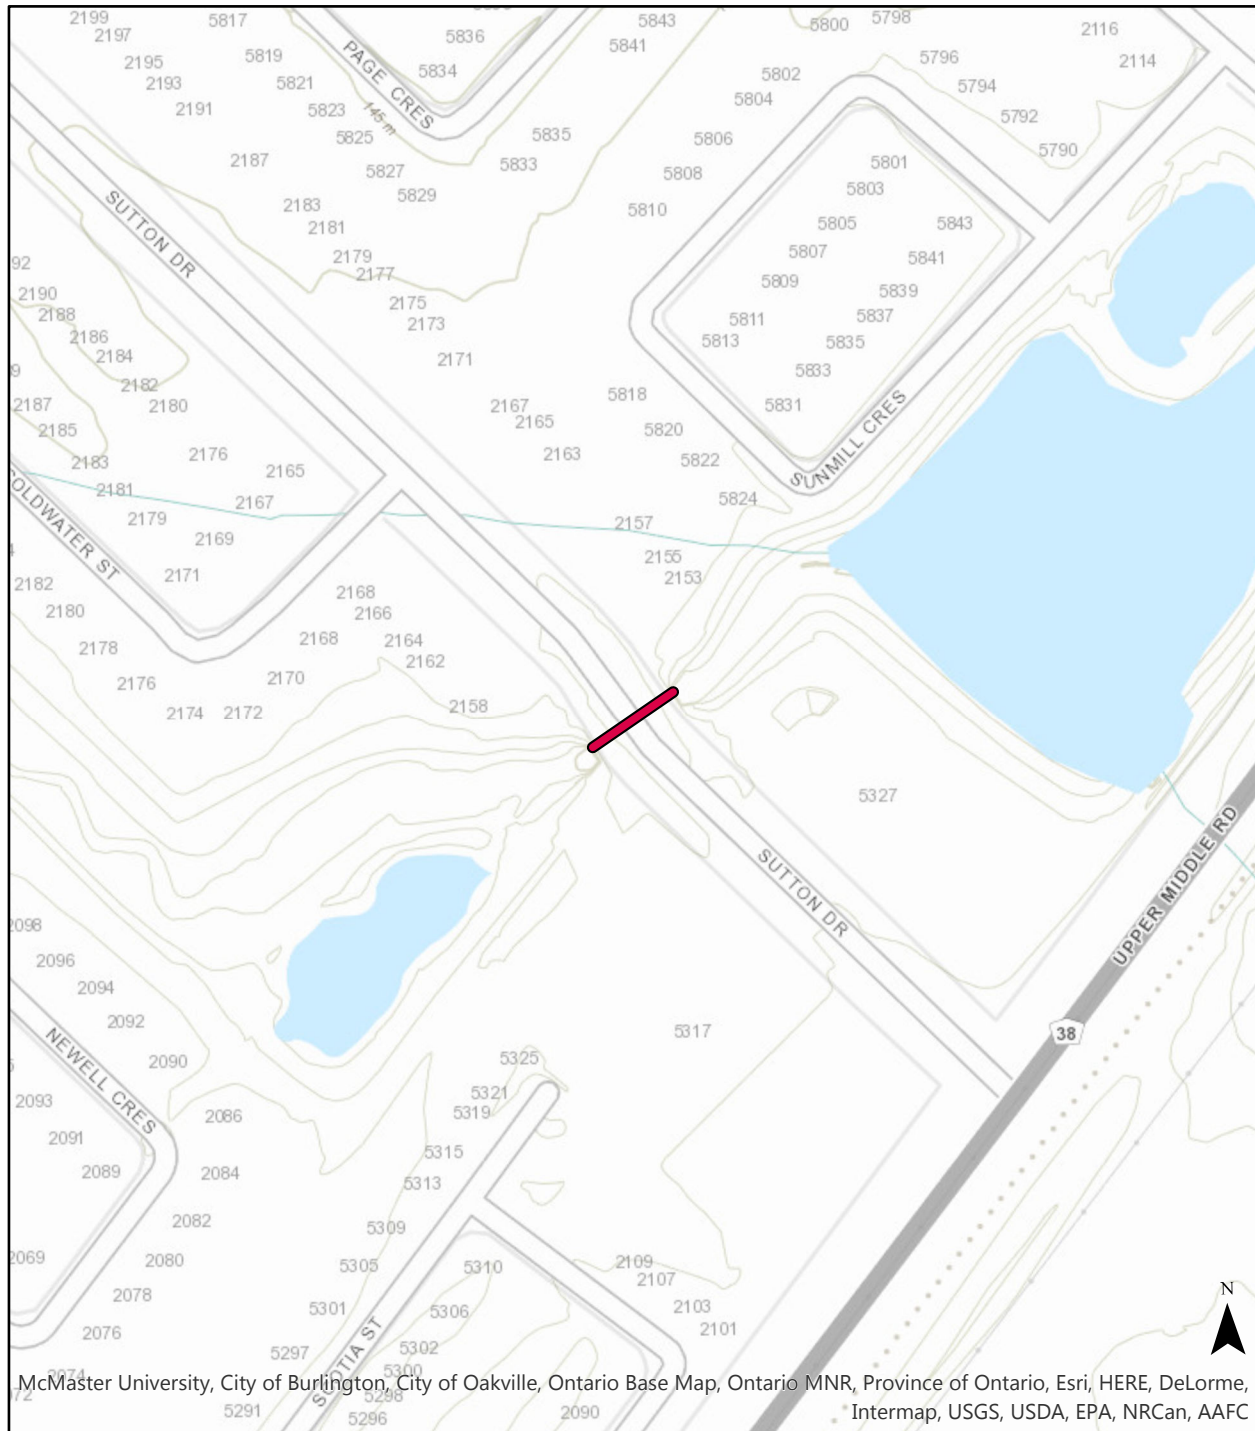
Asset ID: 5091

Condition: Good

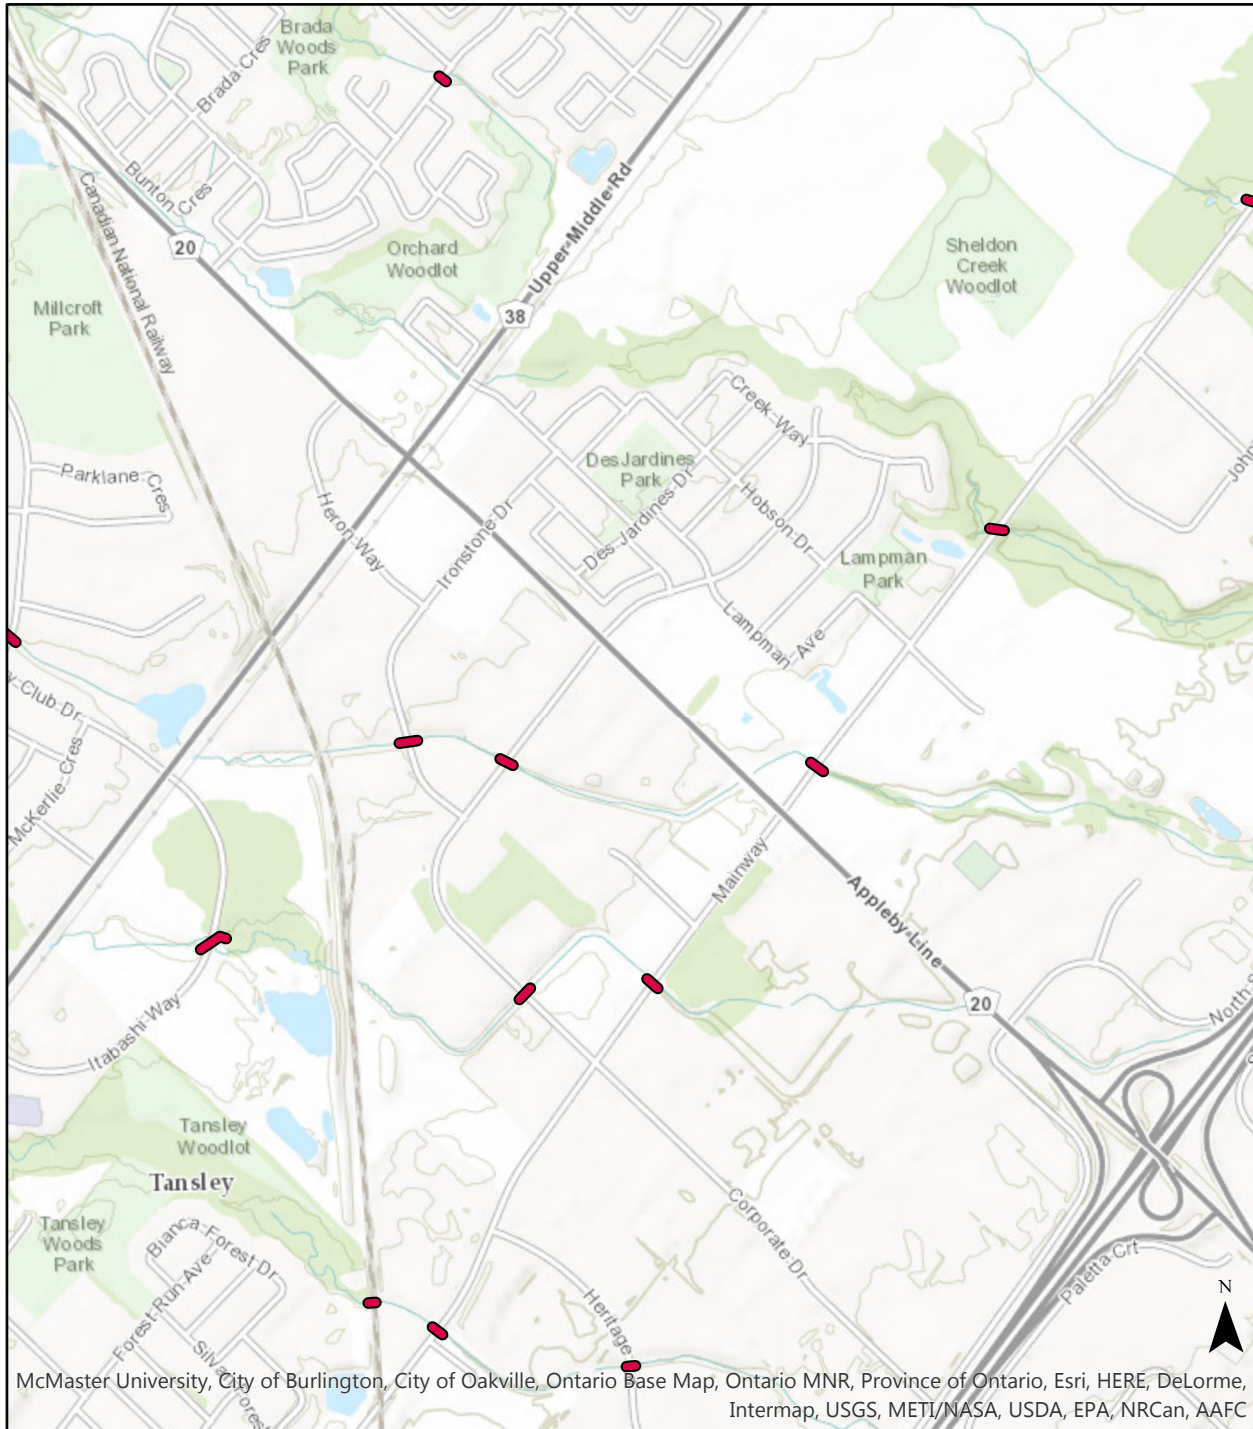
Asset ID: 5096

Condition: Fair
